DATE: March 23, 2017

RE: Potential Oil Seal Leaks with P54, P58, and P59 Pumps

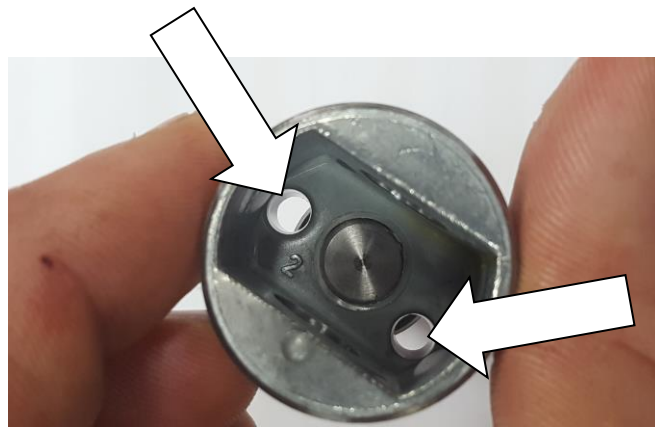
Figure 1: Old Crosshead Design

Between 3/23/15 and 12/31/16 the P54, P58, and P59 pumps went through a design change of the crosshead/steel plunger. Prior to this design change the crosshead (Giant Part#: 07777) was two separate parts combined into an assembly. In this case, there were two holes for oil to drain through and return to the pump.

Previous design with two oil return holes and no milled flats

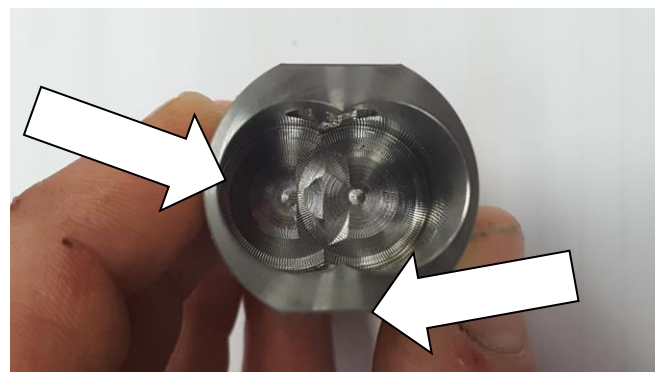
Figure 2: Current Crosshead Design

The current crosshead assembly is a single piece, machined out of a steel slug. This part has two milled flat edges and currently does not have the oil return holes. Without these holes pressure is created between the crosshead and the oil seal. Along with this pressure increase, pulsations are created which cause vibration on the plunger oil seal. Which could result in an oil leak.

New design with milled flats and no Oil return holes

The crosshead machining process will be updated to include these two oil return holes.
All future pumps will now be built with the updated crossheads.
For existing pumps, Giant will replace the crossheads with the updated design described above.
