## REPAIR INSTRUCTIONS - P217/P218/P219/P220/P221/P227/P230 PUMPS

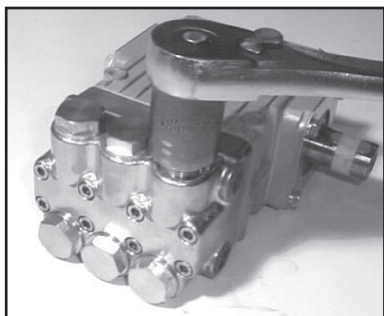
1. With a 22mm socket wrench, remove the (3) discharge valve plugs and (3) inlet valve plugs (32) Inspect the o-ring (33) for wear and replace if damaged.

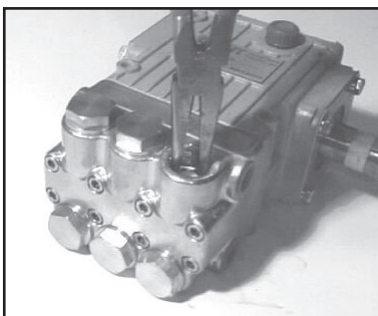
2. Using a needle nose pliers, remove the inlet and discharge valve assemblies (32X).

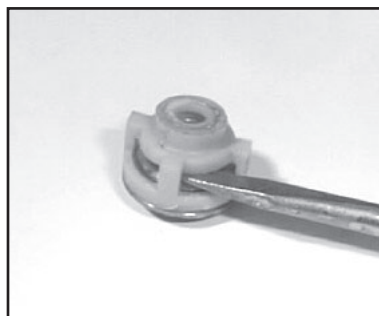
3. By inserting a small screw driver between the valve seat (27) and the valve spring retainer (30), the valve assembly can be separated.

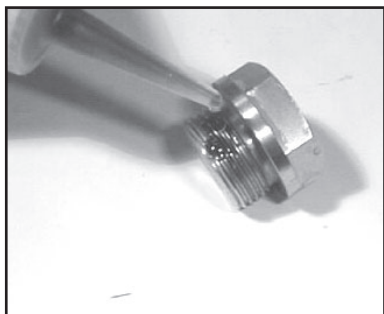
4. Remove the o-ring (31). Inspect all parts for wear and replace as necessary. Apply one drop of Loctite 243 to the valve plugs (32) and tighten to 55 ft.-lbs. (75 Nm)

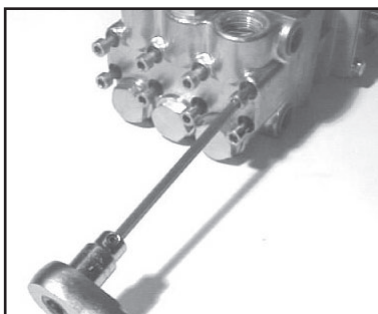
5. Next, use a 5mm allen wrench to remove the 8 socket head cap screws (34).

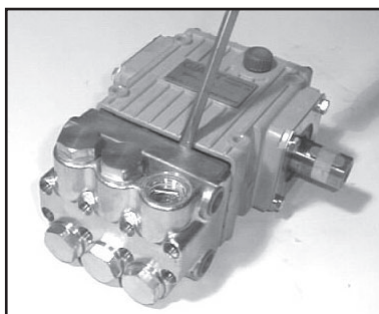
6. Carefully slide the valve casing (26) out over the plungers.

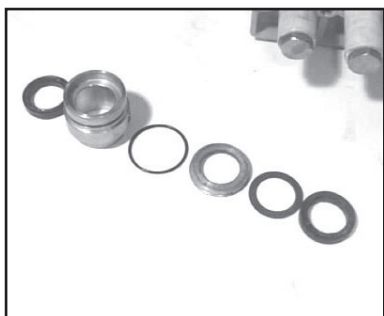
7. Remove the weep return ring (25), pressure ring (24), and v-sleeve (23) from the valve casing (26). Remove the v-sleeve (23A) from the seal case (20). Inspect all parts, including o-ring (21) for wear and replace as necessary

8. Check surfaces of plunger (16). A damaged surface will cause accelerated wear on the seals. Deposits of any kind must be carefully removed from the plunger surface. A damaged plunger must be replaced!

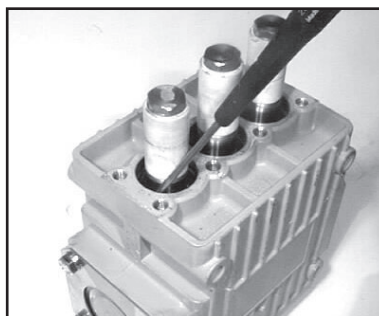
9. If the crankcase oil seals (19) are to be replaced, they can be removed by prying loose with a flat screwdriver. Take care not to make contact with the plunger.
