REPAIR INSTRUCTIONS - P435/P450/P451/P455B/P456

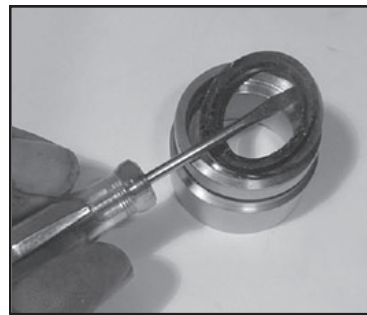
- 8) Remove the weep grooved seal (23) out of the seal adaptor (20). Check O-rings (21).

IMPORTANT! The grooved seal (23) on the high-pressure side is to be fitted carefully into the valve casing (26) using a screwdriver. Under no circumstances must the seal surface in the valve casing or the seal lip be damaged.
