Model 22860P

Pneumatic Pressure Relief Valve

Spare Parts List

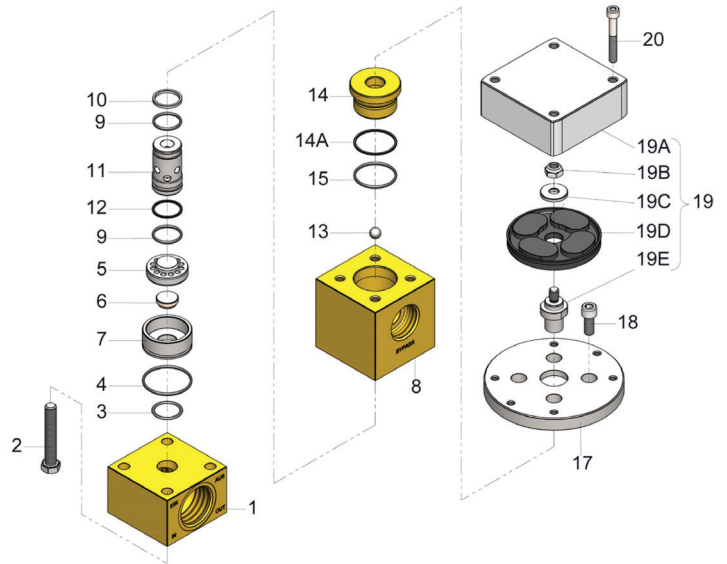
Exploded View

Item	Part #	Description	Qty.
1	04978	Connection Block	1
2	04979	Hexagon Screw	4
3*	07214	O-Ring	1
4*	13141	O-Ring	1
5	05949	Valve Cone	1
6*	05950	Sealing Cone	1
7*	05951	Valve Seat	1
8	04980	Casing	1
9*	07214	O-Ring	2
10*	05953	Guide Ring	1
11	04981	Piston	1
12*	06361	Support Ring for O-Ring	1
13	12014	Ball	1
14	04982	Centering Ring	1
14A*	07701	Support Ring	1
15*	07140	O-Ring	1
16	05957	Pressure Pin	1
17	04033	Cylinder Retainer	1
18	07008	Inner Hexagon Screw	8
19	03593	Cylinder Assembly	1
19A	03594	Cylinder	1
19B	04036	Hexagon Nut	1
19C	03580	Washer	1
19D	06435	Sleeve	1
19E	03596	Pressure Pin	1
20	08363	Cylinder Screw	1

* 09717A Repair Kit

In time, the valve may leak even when the piston is set at the correct air pressure. The leakage would be due to damage in the sealing chamber on the seat (7) and/or the sealing cone (6). To repair the valve, unscrew the hexagon screws (2) from the connection block (1), remove the cylinder assembly (19) by removing screws (18), and press all inner parts out from the top of the casing. Check the seat (7), cone (6), O-rings (3 & 4), and renew parts.
