## LP121A-5121 - Repair Instructions

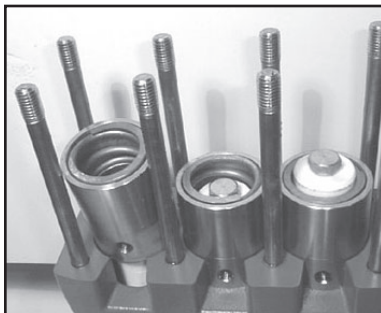
6. Pull seal sleeves (35) out of guides in crankcase (1).

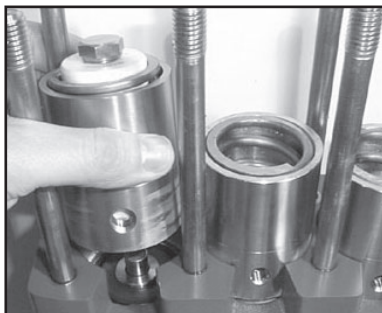
10. Place new plunger pipe (29B) carefully through the oiled seals and push seal sleeve (35) with plunger pipe into the crankcase guide. **Note: Make sure weep hole is facing down.**

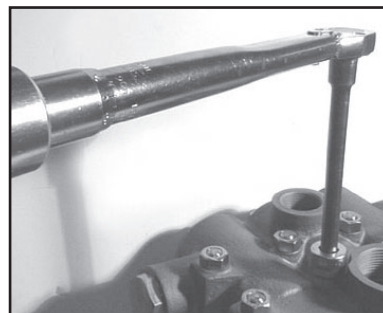
12. Place valve vasing (43) over studs and push firmly until seated against the crankcase (1). Tighten the hexagon nuts (49A) in a crosswise pattern (shown below) to 59 ft.-lbs. (80 NM)
