Repair Instructions - CP420-5123 and CP425-5123

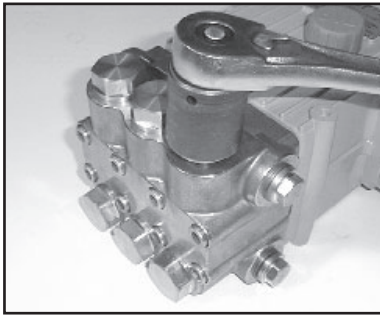
- 1) With a socket wrench, remove the three discharge valve plugs and three inlet valve plugs (32). Inspect the o-ring (33) for wear and replace if damaged.

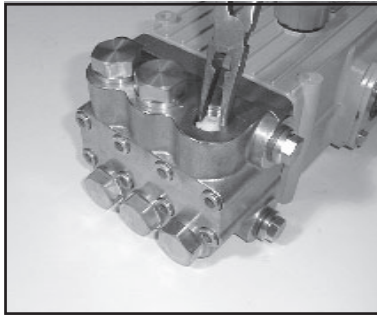
- 2) Using needle nose pliers, remove the inlet and discharge valve assemblies (27A). Note: It may become necessary to remove the valve seat (27) from the valve casing using a slidehammer.

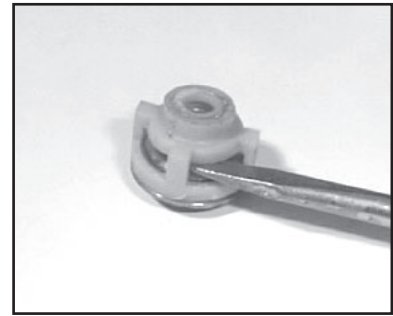
- 3) By inserting a small screw driver between the valve seat (27) and the valve spring retainer (30), the valve assembly can be separated.

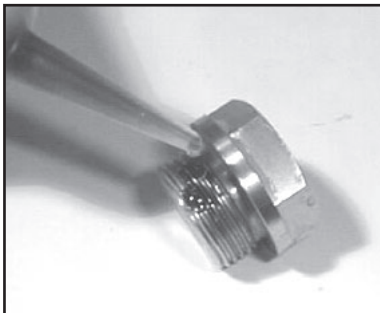
- 4) Remove the O-ring (31). Inspect all parts for wear and replace as necessary. Apply one drop of loctite 243 to the valve plugs (32) and tighten to 107 ft.-lbs. (145 NM).

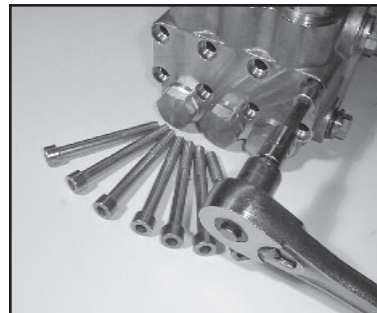
- 5) Use a 8mm allen wrench to remove the 8 socket head cap screws (34). Carefully slide the valve casing (26) out over the plungers.

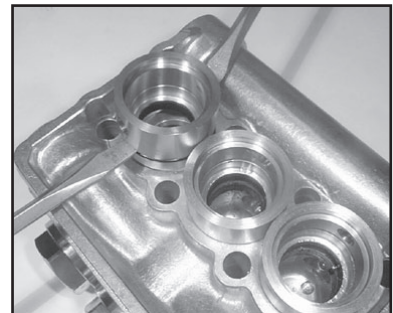
- 6) Remove seal adapters (20) and weep return rings (25) from the valve casing.

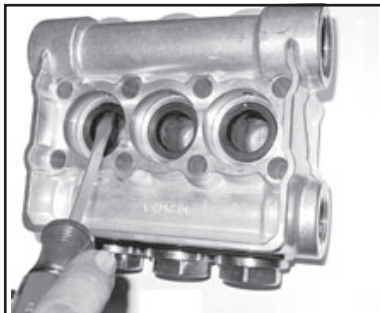
- 7) Remove the pressure rings (24) and v-sleeves (23).

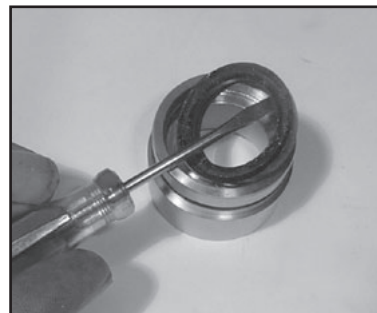
- 8) Remove the weep grooved seal (23B) together with pressure ring out of the seal case (20). Check O-rings (21).

IMPORTANT! The grooved seal (23) on the high-pressure side is to be fitted carefully into the valve casing (26) using a screwdriver. Under no circumstances must the seal surface in the valve casing or the seal lip be damaged.

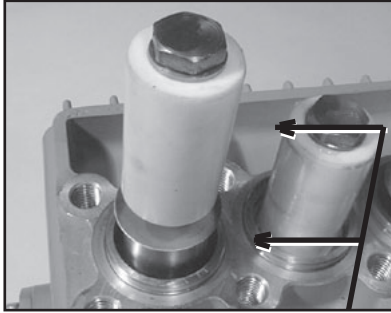
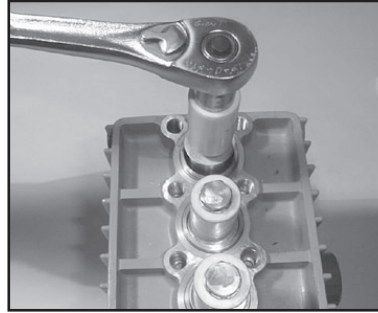
Plunger surfaces are not to be damaged. If there are lime deposits in the pump, care must be taken that the drip-return bore in parts (25) and (26) ensure trouble-free drip-return.

- 9) Check surfaces of plunger (16). Damaged surfaces cause accelerated seal wear. Deposits of all kinds must be removed from the plungers.
- 10) If the plunger pipe (16B), is damaged or worn, remove tension screw (16D) and plunger pipe (16B). Check and clean plunger surface (16A) and check flinger (16H). Cover thread of tension screw (16D) with a thin film of Loctite 243 and tighten carefully to 22 ft.-lbs. (30NM).
