## REPAIR INSTRUCTIONS - P225/P226/P223/P228 PUMPS

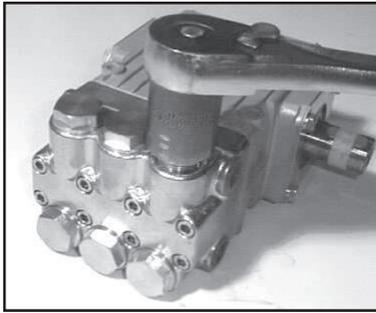
1. With a 22mm socket wrench, remove the (3) discharge valve plugs and (3) inlet valve plugs (32) Inspect the o-ring (33) for wear and replace if damaged.

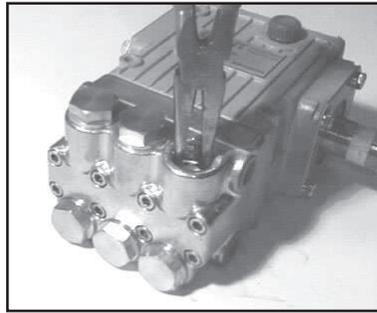
2. Using a needle nose pliers, remove the inlet and discharge valve assemblies (32X).

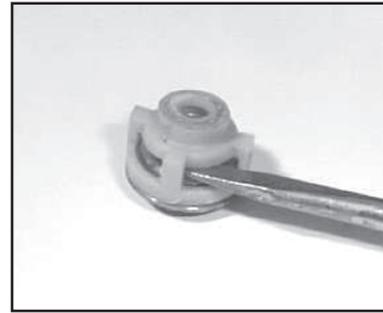
3. By inserting a small screw driver between the valve seat (27) and the valve spring retainer (30), the valve assembly can be separated.

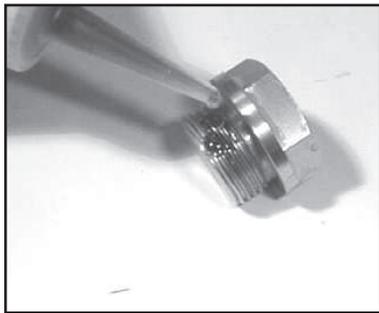
4. Remove the o-ring (31). Inspect all parts for wear and replace as necessary. Apply one drop of Loctite 243 to the valve plugs (32) and tighten to 55 ft.-lbs. (79 Nm).

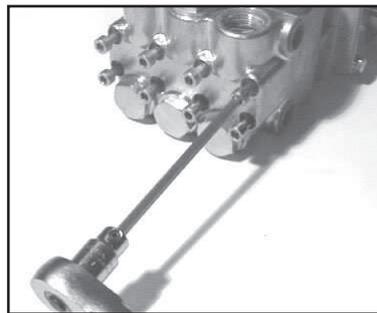
5. Next, use a 5mm allen wrench to remove the 8 socket head cap screws (34).

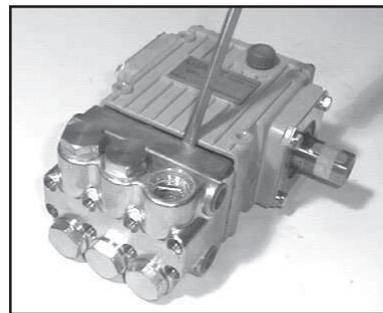
6. Carefully slide the valve casing (26) out over the plungers.

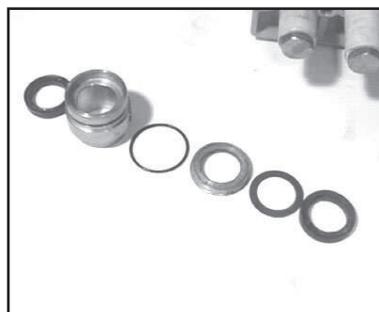
7. Remove the weep return ring (25), pressure ring (24), and v-sleeve (23) from the valve casing (26). Remove the v-sleeve (23A) from the seal case (20). Inspect all parts, including o-ring (21) for wear and replace as necessary

8. Check surfaces of plunger (16). A damaged surface will cause accelerated wear on the seals. Deposits of any kind must be carefully removed from the plunger surface. A damaged plunger must be replaced!

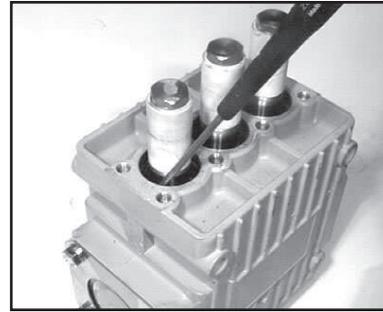
9. If the crankcase oil seals (19) are to be replaced, they can be removed by prying loose with a flat screwdriver. Take care not to make contact with the plunger.
