REPAIR INSTRUCTIONS - P300 SERIES - 12 and 20 MM VERSIONS

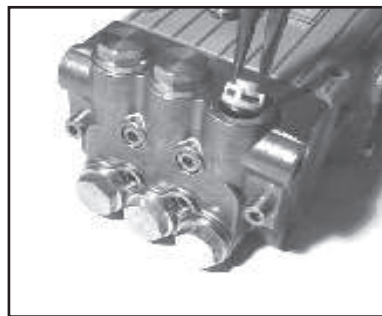
2. Using a needle nose pliers, remove the inlet and discharge valve assemblies (#32X).

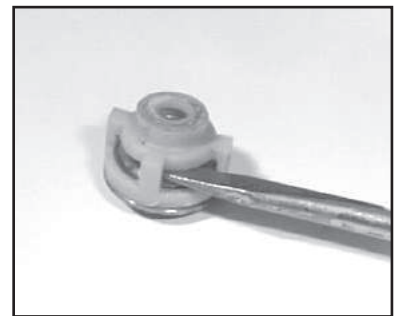
3. The valve assemblies can be separated by inserting a small screw driver between the valve seat (#27) and its valve spring retainer (#30).

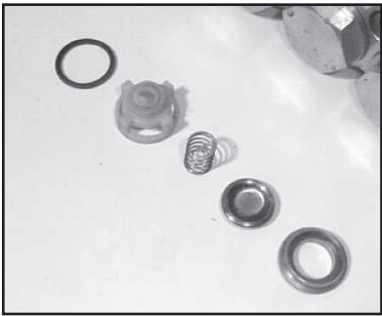
4. Remove each o-ring (#31). Inspect all parts for wear and replace as necessary. Reassemble valve assy's (#32X) & place in valve casing (#26).

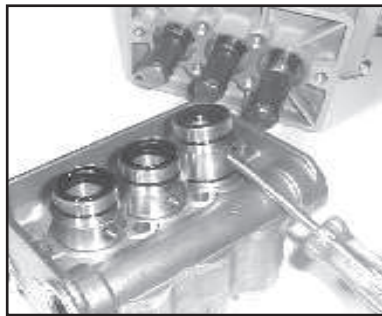
8. Remove weep return rings (#25) from the plungers (#16). Remove the seal case (#20) from either crankcases (#1) or manifold (#26) by using a screwdriver as shown above.

NOTE: If there are deposits of any kind (i.e., lime deposits) in the valve casing, be certain the weep holes in the weep return ring (#25) and valve casing (#26) have not been plugged.

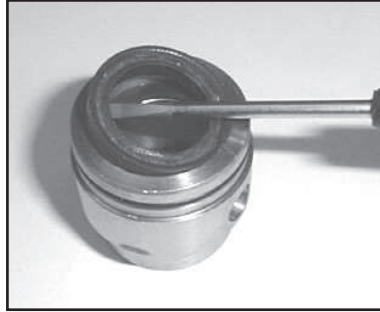
10. Remove the weep grooved seals (#23A for P314, P321 & P327 and #23 for P318, P324 & P330) from the seal case (#20).

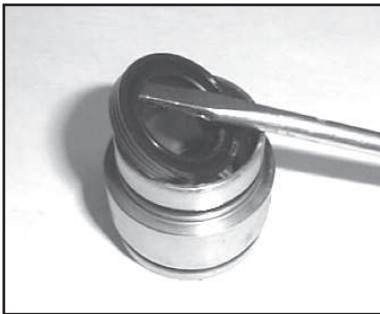
12. For P314, P321 & P327 pumps, use a flat screw driver to pry the oil seals (#19) loose from the seal case (#20).

Note: Occasionally, the above procedure can be carried out for P318/P324/P330 pumps. However, for P318/P324/P330 pumps which have the oil seals that remain in the crank-case, use a 6mm allen wrench to first loosen and remove the tension screw (#16C) from the plunger pipes (#16B). Use a flat screwdriver to pry the oil seals loose from the crank-case (#1).
